Within Conservation Areas: Acceptable example of plans/photographs to accompany applications for windows

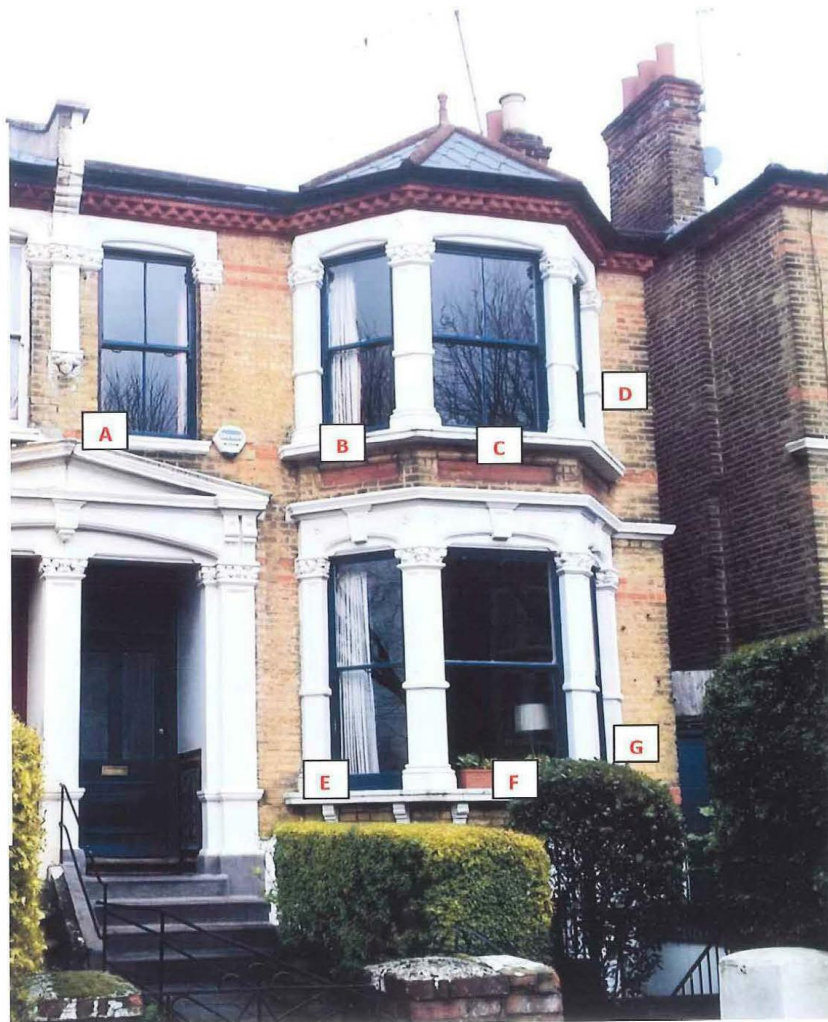
PICTURE 1

Clearly labelled windows on a photograph showing the whole frontage of the building.

FRONT UPPER
BAY WINDOWS
& SIDE WINDOW

FRONT LOWER
BAY WINDOWS

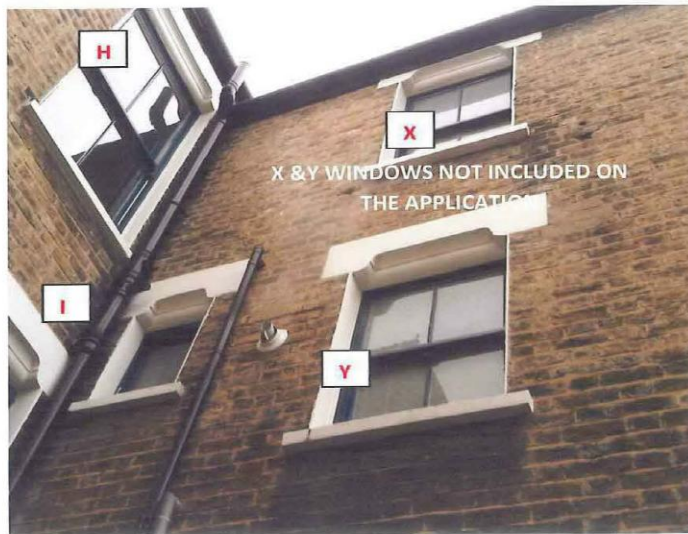
PICTURE 3

[X & Y]
WINDOWS X & Y
NOT TO BE
REPLACED & NOT
INCLUDED IN THE
APPLICATION
