3 Areas of weakness and potential for enhancement

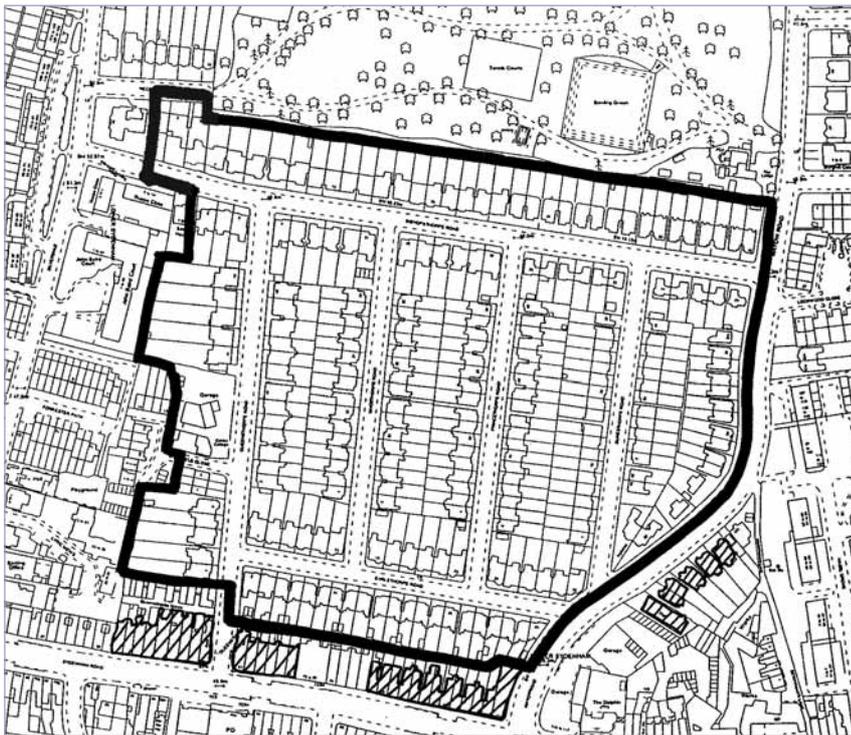
Figure 41 shows buildings within the setting of the area that have a particularly positive impact on these views and on the character of the setting in general.

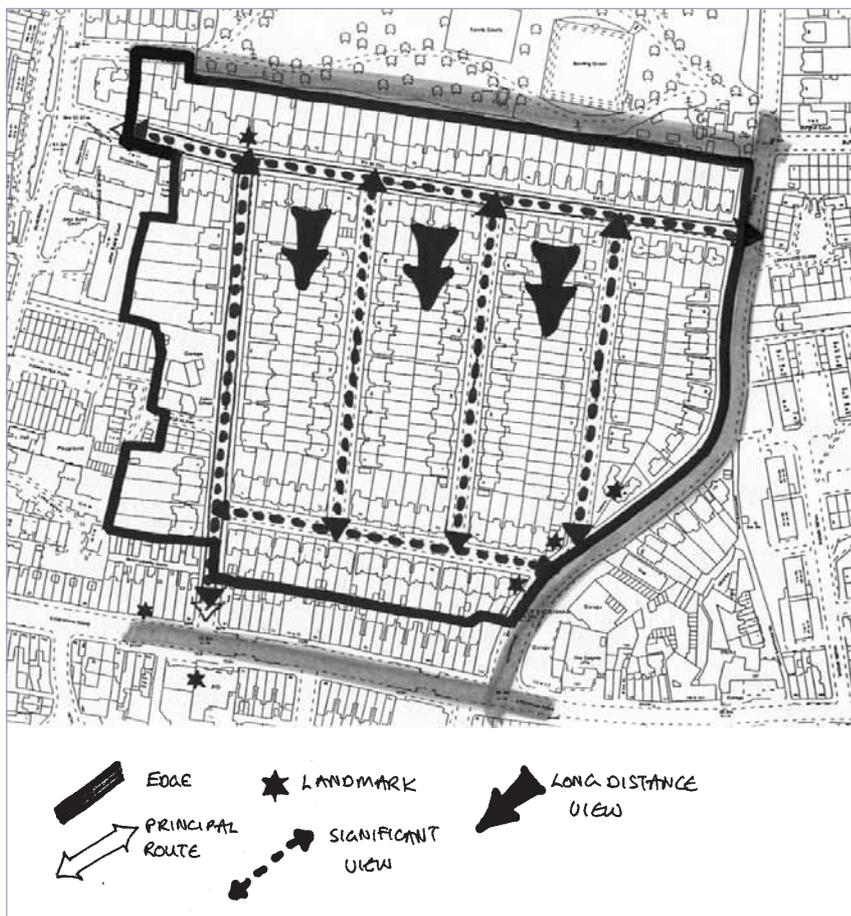
Figure 42: Townscape analysis of the conservation area.

Figure 42 gives a full townscape analysis of the conservation area within its setting.

The sloping nature of the site contributes to a series of attractive views along its long straight streets. There are a number of significant views into and out of the conservation area – these are dependent on the street layout and are indicated in Figure 42. In addition, there are long-distance views from the top of the site towards wooded hills to the south.

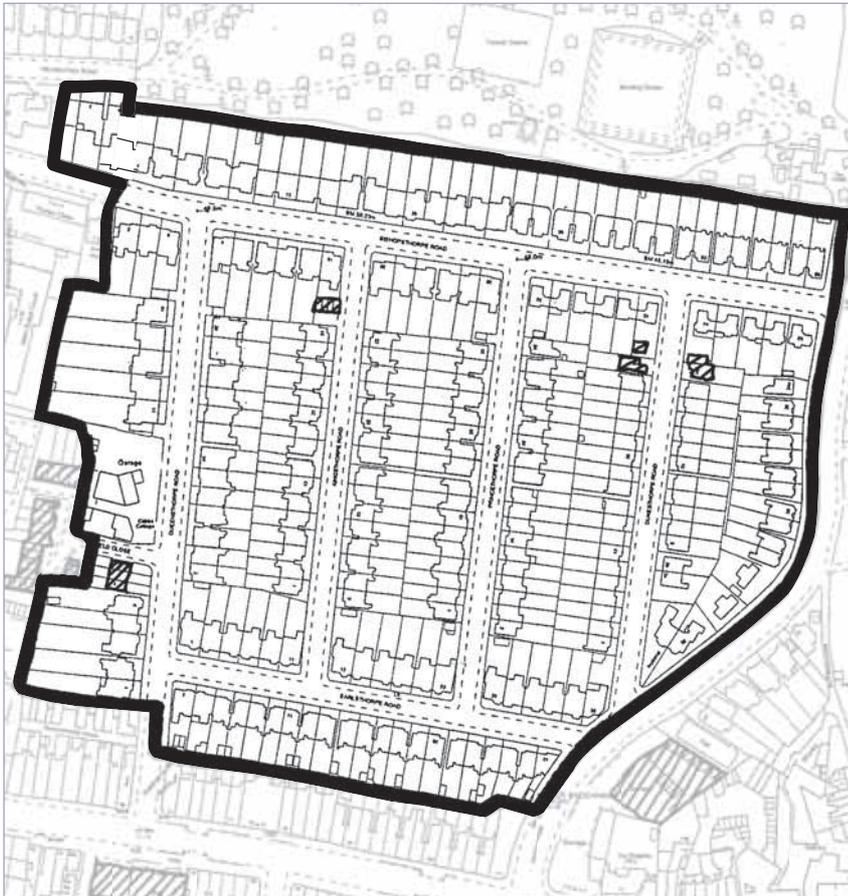
Figure 43: Sites with the potential for enhancement within the conservation area and its setting.

Sites shown above are:

- 1–17 (consec.) Windfield Close
- Garages at rear of 18 Bishopsthorpe Road
- 24 and 37 Dukesthorpe Road and adjoining garages
- 42–44 (Post Office) Sydenham Road
- Garage at rear of The Dolphin PH, Mayow Road
- 22–27 (consec.) Lockwood Close, Mayow Road
- 49–149 (odd) Hazel Grove

Certain sites within the conservation area and its immediate setting have either a negative impact on its character and appearance, or are neutral in this respect.

Both these types of site (shown in Figure 43) have the potential for enhancement in terms of the contribution that they make to the character and appearance of the conservation area.

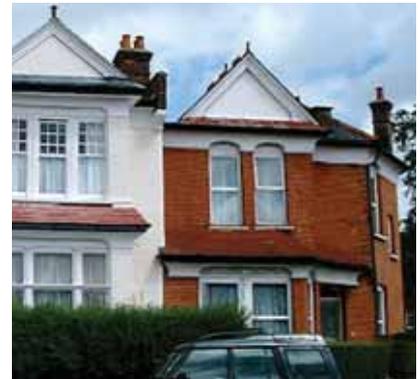
Figure 44

Both of the prominent buildings shown in figure 44 have lost the decorative pargetting to their gables. The brick facade of that to the left has also been painted, further altering its character.

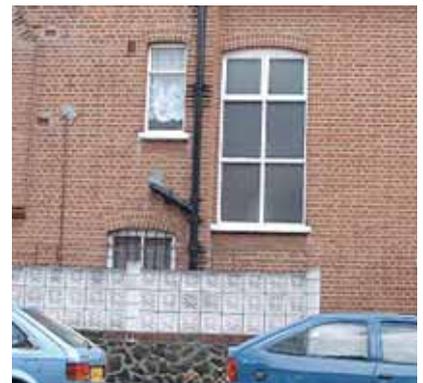
Figure 45

In figure 45 the largest of the windows on the flank elevation of a house on Earlsthorpe Road would originally have had stained glass with a decorative design. Without it, the elevation becomes relatively bland and uninteresting (cf. figure 23g).

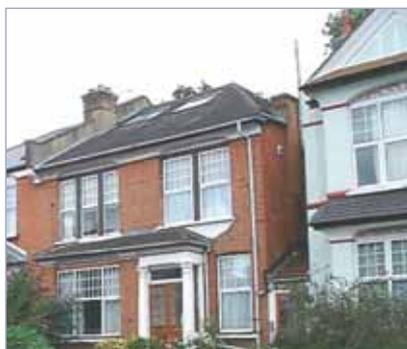
Figure 46a shows rooflights and an unsuitable replacement roof covering detract from this property on Bishopsthorpe Road.

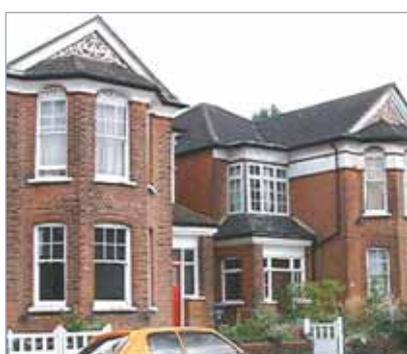
Figure 46b shows replacement roofs in Bishopsthorpe Road. Figure 47 shows houses with concrete roofing tiles (right) and faded artificial slate (left)

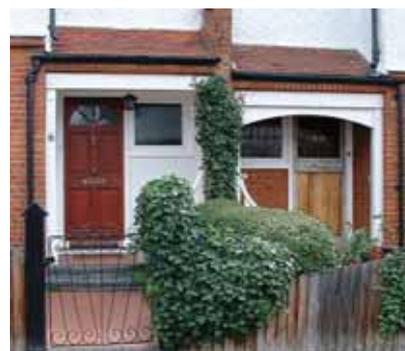
Modern doors also detract from the historic appearance of the streetscape. Figure 48 shows two doors on Dukesthorpe Road. That on the right is original, with proportions and detailing that complement other design features of the house, notably the adjoining sidelight. That on the left is an inappropriate modern replacement – the detrimental impact is obvious.

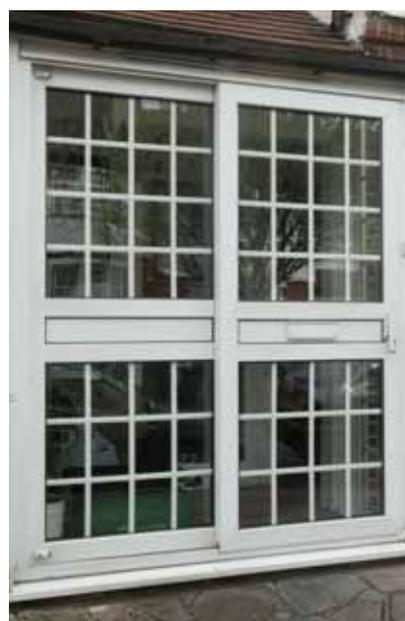
Figure 49 shows a replacement UPVC porch door on Kingsthorpe Road. This bland, modern design obscures the original double doors, which would have been of panelled timber with stained-glass lights (see villa style no 5).

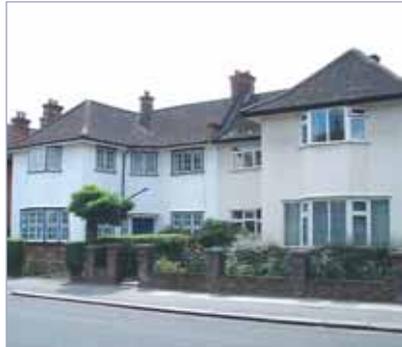
Figure 50 shows a villa pair on Bishopsthorpe Road. The house on the left has its original timber casement windows, whereas the windows of the house on the right are replacement UPVC with 'leaded' lights.

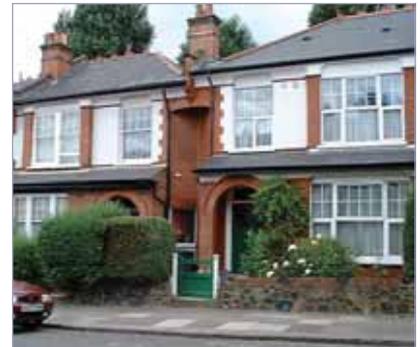
Figure 51 shows two neighbouring houses on Kingsthorpe Road. The one on the left has its original timber sash windows, the one on the right has replacement UPVC casements.

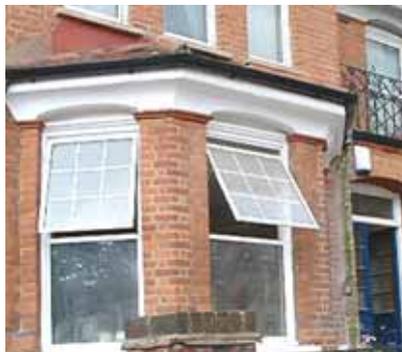
Figure 52

Figure 52: A house on Queensthorpe Road. Although the replacement UPVC windows imitate the glazing pattern of the original sashes, they lack the design quality and the craftsmanship of the originals.

For instance, the fake 'glazing bars' of the upper 'sash' are sandwiched between the panes of the double glazing – as a result the window appears flat and two-dimensional in comparison to traditional timber sashes. The opening mechanism is another obvious point of difference.

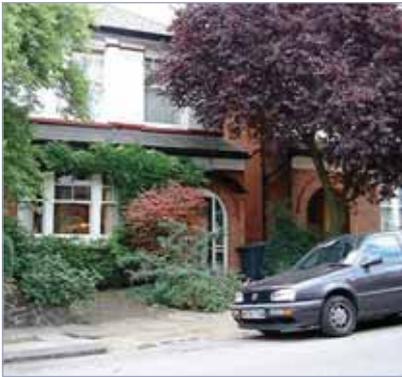
Figure 54 shows a house on Kingsthorpe Road which has lost its front garden wall, to the detriment of the character of the road.

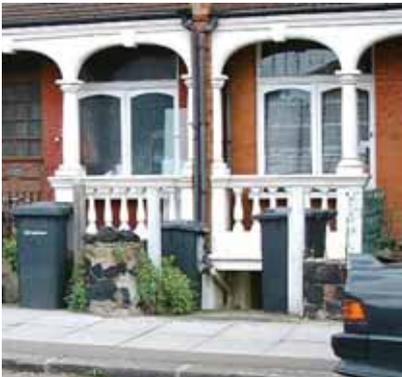
Figure 55 shows gates and posts to the front of these properties on Queensthorpe Road which have been removed to allow for wheelie-bin storage. The negative impact on the setting of the houses from the loss of the original boundary treatment and from the bins themselves is obvious.

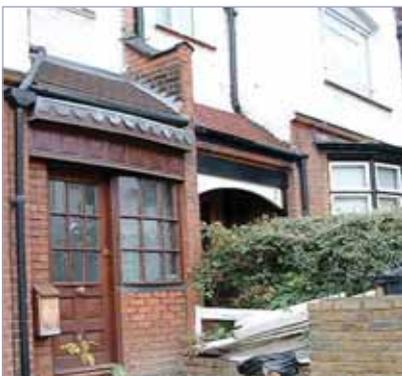
Figure 56 shows a porch of a house on Dukesthorpe Road has been enclosed in a highly unsympathetic fashion. Original porches, where they survive, are one of the most attractive features this villa style (see villa style 6).

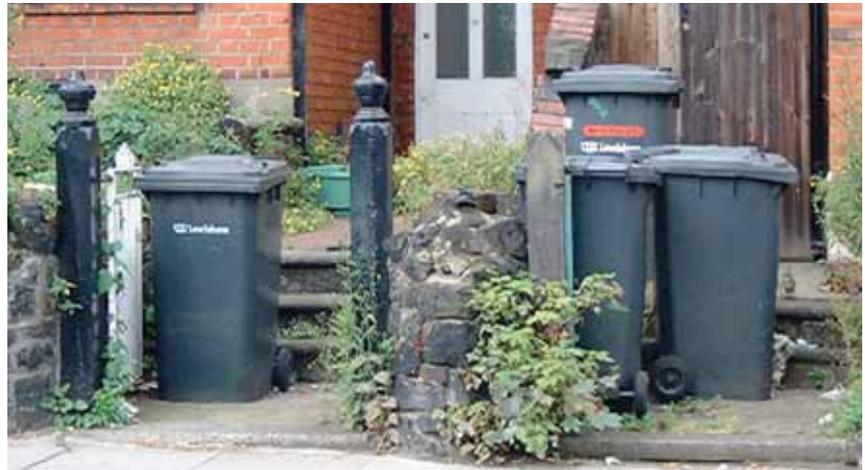
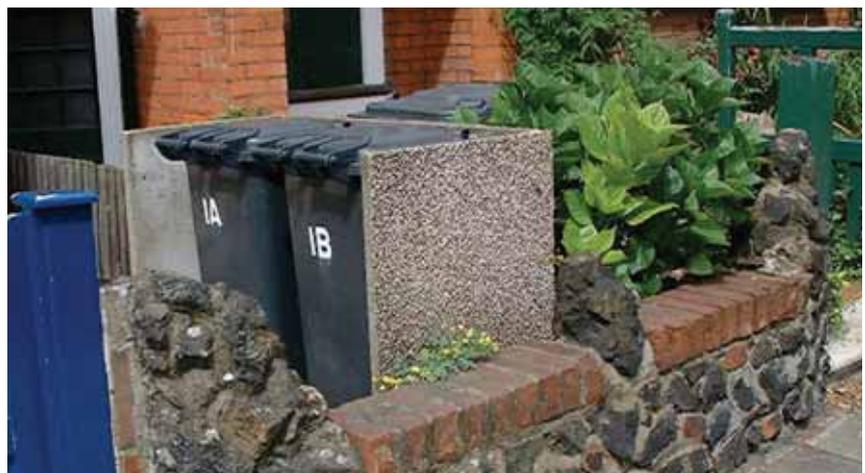
In some places, notably Queensthorpe Road, front boundaries and/or gates have been removed to allow the bins to be drawn in off the pavement. The loss of original boundary treatments compounds the negative visual impact of the bins themselves.

The pictures on this page show unattractively located wheelie bins.

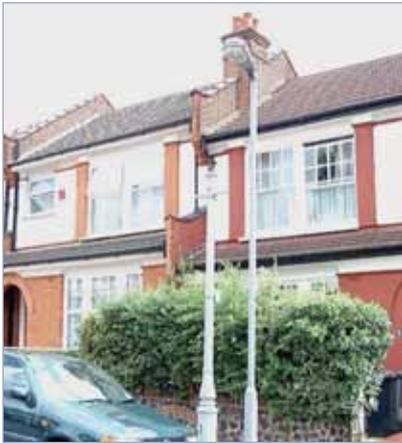
Figure 61 shows a disused lamp column with modern replacement. The modern lamp, unlike its predecessor, detracts from, rather than enhances the period atmosphere of the estate.

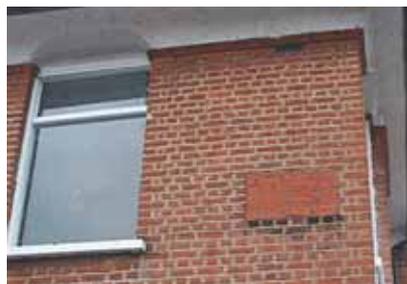
Figure 62 shows where the street sign has been removed from this house wall.

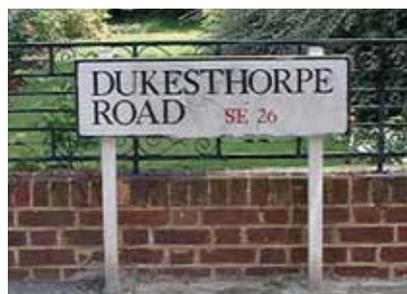
Figure 63

Modern street signs lack the character and period feel of the original wall-mounted signs

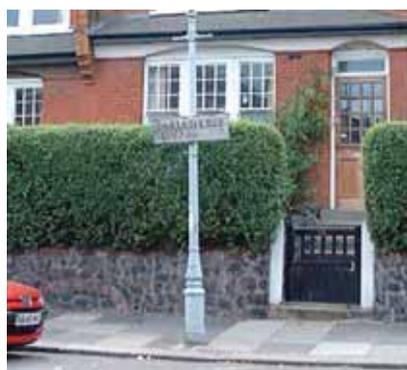
Inappropriately placed street furniture such as this sign shown in Figure 64 can add clutter to the street scene and detract from period features.

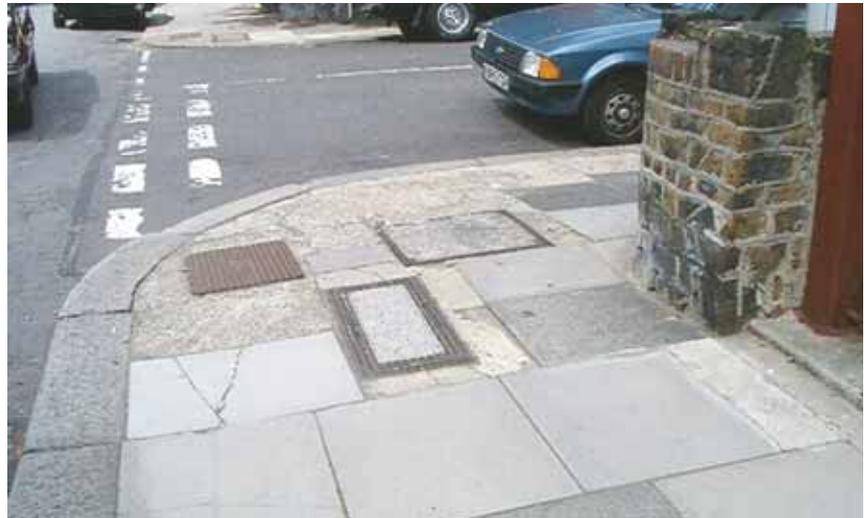
Road surfaces are potholed and patched in different coloured concrete. Pavements are largely of concrete slabs, which are often broken or uneven, edged or patched at the kerb or around manhole covers with various colours of concrete.

Figure 65: Poor quality paving in Earlsthorpe Road.
